LIGHTHOUSE INSPECTIONS, LLC
122 Old Post Road
Old Saybrook CT 06475
860-615-0000
drterray@gmail.com Lighthouse-inspections.com

Confidential Inspection Report

Estimated Age: Historic 1665.	Building Style & Type: Saltbox.	Stories: 3	Space Below Grade: Basement, Crawl space.
Water Source: Public.	Sewage Disposal: Private.	Utilities Status: All utilities on.	Main Entry Faces: Street, North.

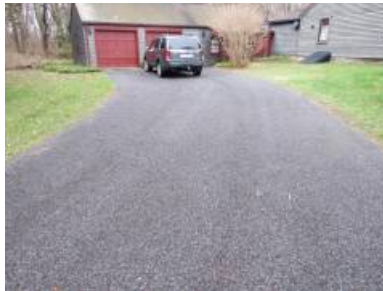
Driveway:

OK MM RR
 Driveway Type: Loose gravel.

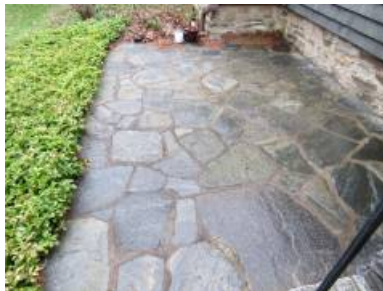
Walks:

Sidewalk type: Flagstone.

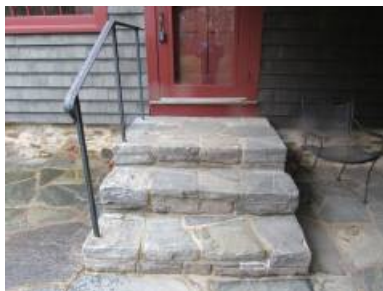
Exterior Steps / Stoops:

Handrails serviceable.

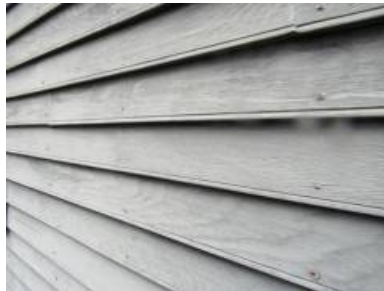
Materials & Condition:

OK MM RR
 Walls are constructed with [wood Clapboard].

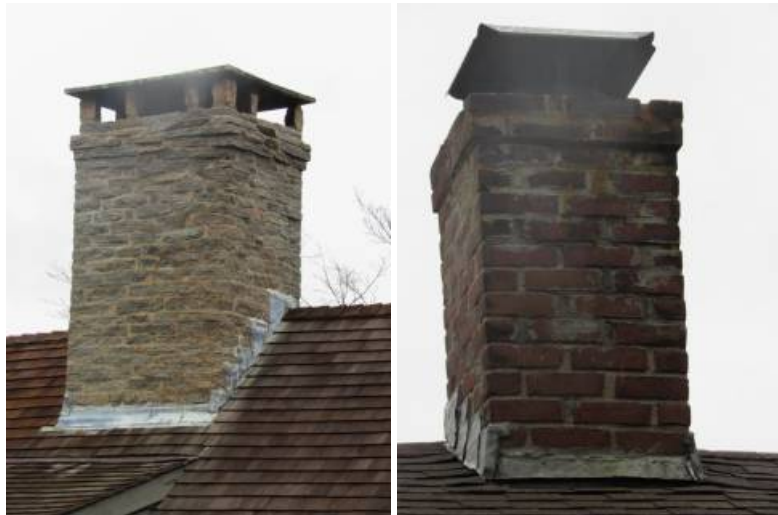
Flue:

Unlined flue- For safety reasons, the fireplace flue should be lined with either a tile or a metal liner as required by the local jurisdiction or the manufacturer. The inspection is limited to the visible portions of the fireplace flue. Drop light, mirrors, and smoke testing are not a part of the inspection. Visibility is limited to as little as 20% of the flue. If further investigation is recommended, the services of a qualified professional chimney sweep should be obtained.

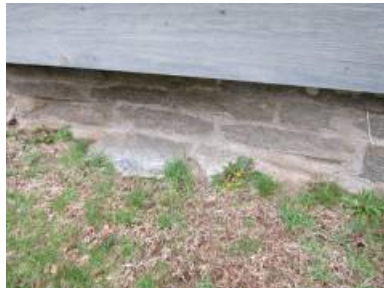
Foundation:

Stone - Masonry walls. Stone with masonry joints were common in homes built before 1950.

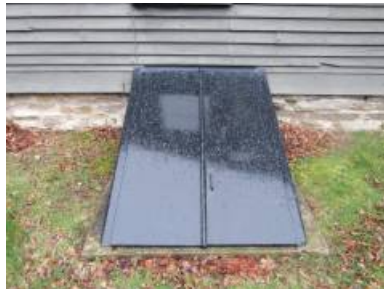
Basement:

- Walls: OK MM RR Walls are stone. Bowing in at least one exterior wall was noted. Typical bowing cracks noted. A pair of angular cracks radiating from the lower outside walls toward the midspan with a vertical crack near the center of the wall. There is some form of repairs made to some portion of the walls. The inspector was unable to determine the age of the repairs or the effectiveness of the repairs made. The repairs are described, but the inspector accepts no liability for the repairs or their effectiveness. It is strongly recommended that you investigate the source of the repairs made with the current owner prior to closing. If possible, determine who made the repairs and what warranty if any remains.

- Moisture: OK MM RR Efflorescence.
- Beams/Underfloor: OK MM RR A foundation contractor should install additional supports as needed.
- Posts/Piers & Columns: OK MM RR

- Floor: OK MM RR Concrete, Cracks were noted in the slab floor. Unless otherwise noted, the cracks appeared to be nothing more than curing cracks.
- Windows: OK MM RR The windows as installed are not egress accessible. As a result of the

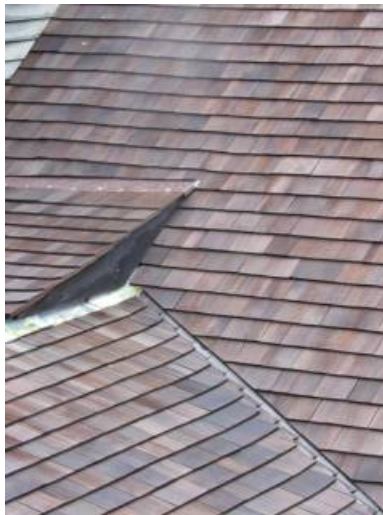
Roof Covering: OK MM RR
 Wood shingles. 3-tab shingles over garage.

Roof Covering Condition: Appears serviceable.

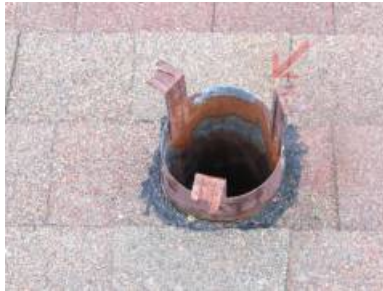
Vent Pipe

OK MM RR
 Metal, Damage is noted at the vents cap missing.

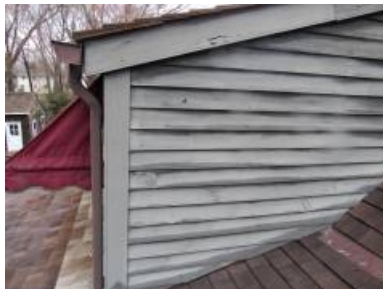
Soffits and overhang materials are wood.

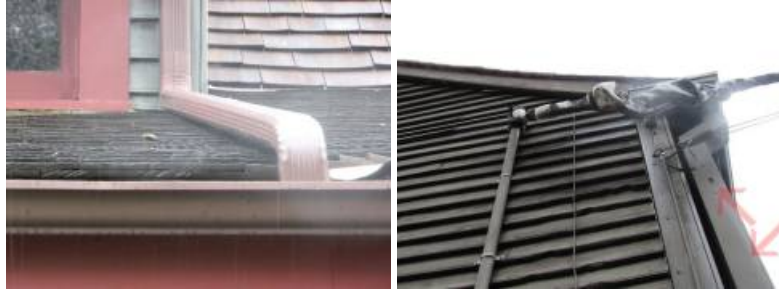
Gutters & Downspouts:

Gutters and downspout materials are aluminum. wood.

Damage/Defects.

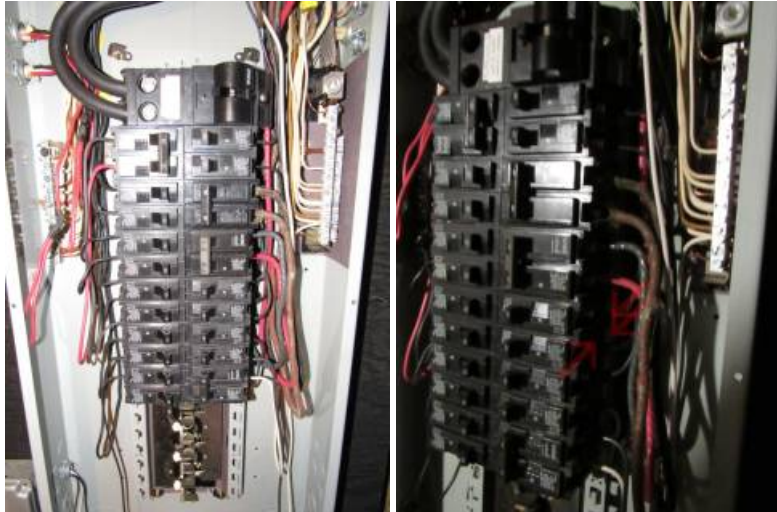
| Main Panel Observations: | Circuit and wire sizing correct so far as visible, Grounding system is present. Double taps noted. Have a licensed electrician make further evaluation and corrections as needed. | | | |

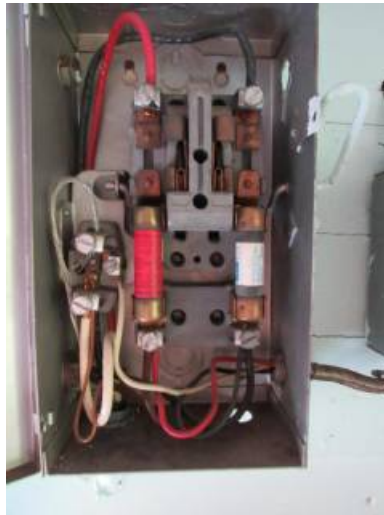
| Subpanels: | <input type="checkbox"/> | <input checked="" type="checkbox"/> | <input type="checkbox"/> | Outdated. Recommend upgrading by licensed electrician. |

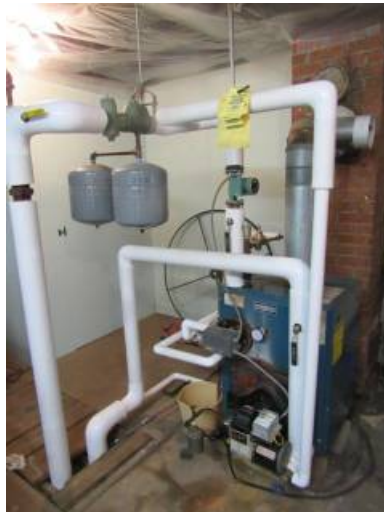
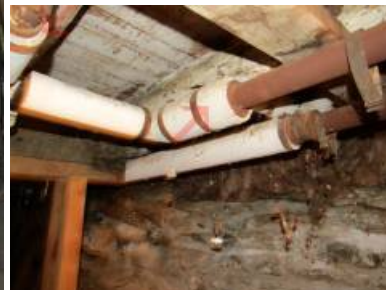
Forced hot water boiler. Asbestos insulation on pipes. Recommend further evaluation by insulation contractor specializing in abatement. Radiators.

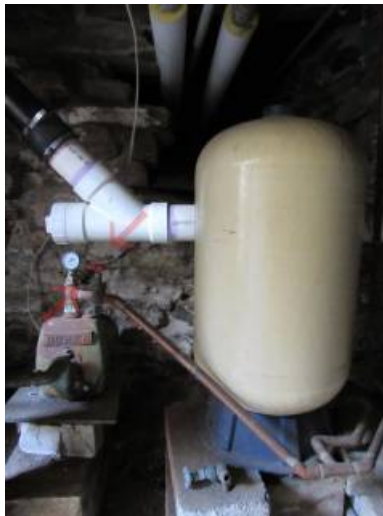
Shut Off:

Main Shutoff Valve, is operational.

Galvanized, Copper, Excessive corrosion is found near the main valve.

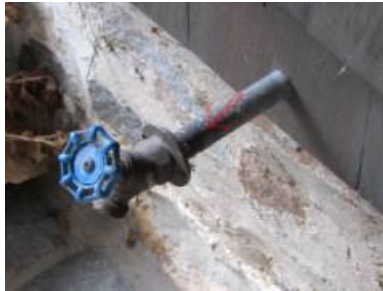
Frost proof type recommended.

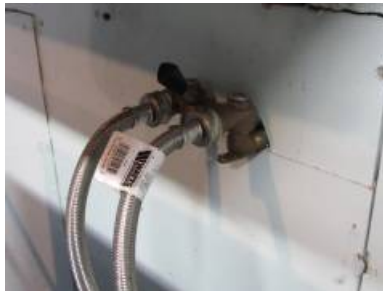
Laundry:

Plumbing appears serviceable.

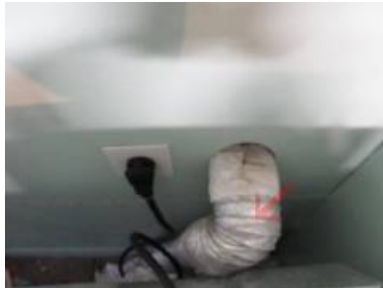
Dryer Vent:

Mylar vent pipe. (Fire hazard) Recommend changing to solid pipe.
